SIGNATURE ANALYSIS OF TRANSMISSION CLUTCH ASSEMBLY

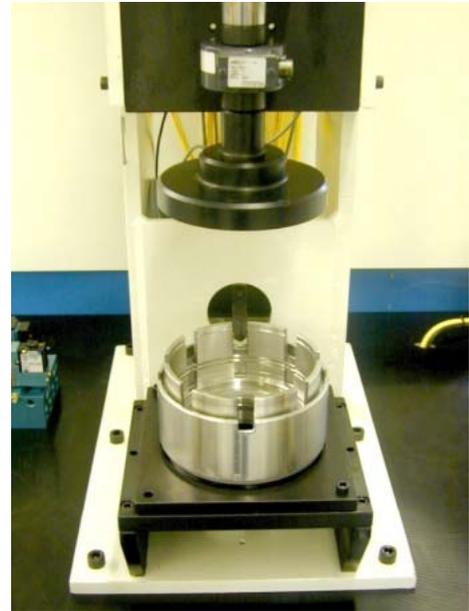
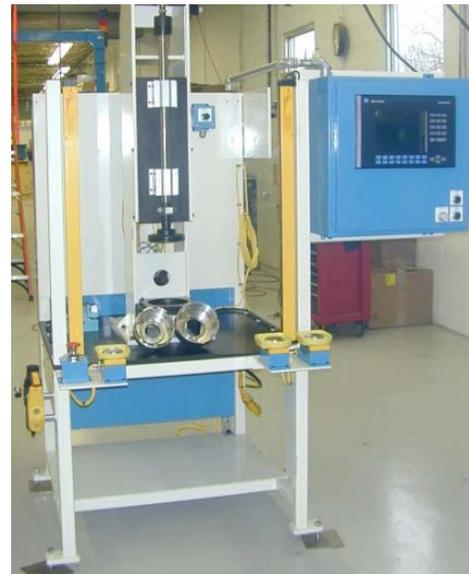
CTS developed a monitoring system to measure the force, displacement and time of the assembly process for the clutch. With this system a typical assembly “signature” was developed to identify properly assembled clutch assemblies. These signatures identified the critical elements of the assembly process and allowed the customer to make adjustments when any part of the signature graph for an assembly exceeded its established limits.
